High Density Polyethylene (HDPE) Lined Produced Water Evaporation Ponds

N. Nowak, PE, Weaver Boos Consultants, Denver, Colorado, USA

J. Bradish, Danish Flats Environmental Services and Southern Cross Environmental Services, Colorado Springs, Colorado, USA

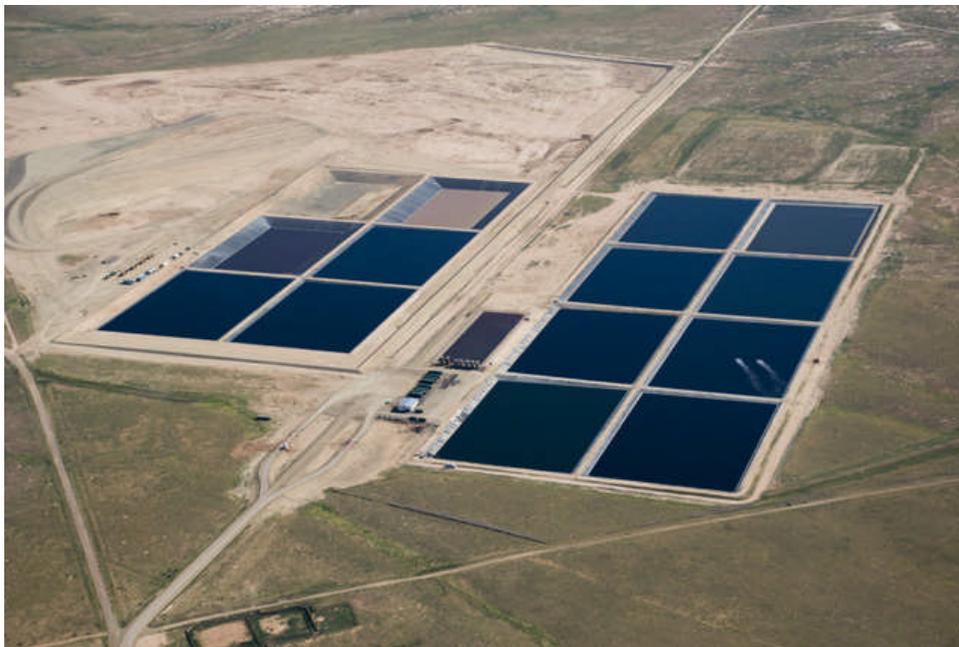
2.4 Aerial Photo of Completed Project at Danish Flats, UT

The partially completed and partially operational project at Danish Flats was photographed from the air on June 29, 2009 and is shown below. The water was distributed from the sludge pond to the Ponds 1 through 12, which appear as “black”. The Ponds 13 appears to have “brownish” water, which includes some construction water is shown in the background and was not yet approved for water disposal at the time of the photography, but has since been put into operation. Currently, all 13 evaporation ponds are operational at Danish Flats.
